IDENTIFYING WORN EPDM BELTS

How To Identify Worn EPDM Serpentine Belts

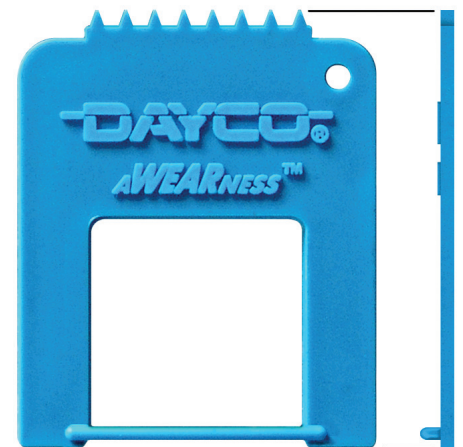
EPDM belt wear can be difficult to detect because the belts tend to wear like a tire, i.e., there is a material loss from the ribs. A new EPDM belt will have a traditional “V” profile in the ribs. With worn EPDM belts however, the “V” profile has the appearance of a “U” instead, because of the material lost from the rib. Once the rib profile is changed, there is less material (and therefore less surface area) coming into contact with the pulleys. This material loss can cause slippage that will affect the performance of the accessories and possibly result in an annoying noisy belt.

New Belt

Worn Belt

We have created an “a-WEAR-ness Gauge” to gauge wear and estimate belt replacement. (Dayco Part Number 047337)

All serpentine belts need to be closely inspected to identify any and all wear. These belts are asked to perform in some of the most hostile environments because of high heat, contaminants and debris. Regular inspection of all drive belts and accessories should be mandatory once the vehicle passes 75,000 miles. Vehicles today have more accessories being driven by a single belt than in years past.

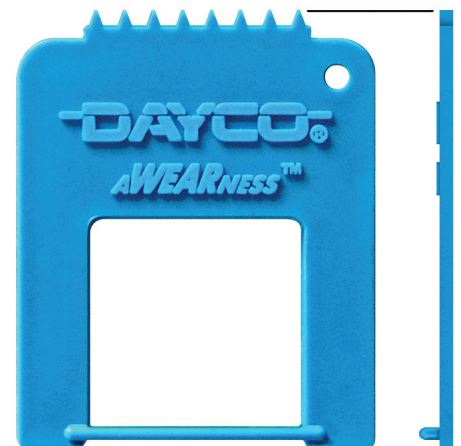
El desgaste de una banda EPDM puede ser difícil de identificar debido a que es similar al desgaste de las llantas, por ejemplo la pérdida de material de los ribs. Una banda serpentinada EPDM nueva tiene el perfil "V" tradicional en los ribs. Con el desgaste, el perfil "V" toma la apariencia de una "U" debido a la pérdida de material del rib. Una vez que el perfil cambia, tenemos menos material (y por lo tanto menos área superficial) en contacto con las poleas. Esto causará que la banda se patine, lo que afectará el buen funcionamiento de los accesorios y provocará ruido desagradable.

Hemos creado el calibrador "a-WEAR-ness Gauge" que ayuda a estimar el desgaste de la banda y su necesidad de reemplazo.

Todas las bandas serpentinadas necesitan ser cuidadosamente inspeccionadas para identificar cualquier desgaste. Estas bandas son sometidas a condiciones más hostiles debido a altas temperaturas, contaminantes y materiales extraños. Una inspección detallada de todas las bandas y accesorios es obligatoria cuando el vehículo sobrepasa las 75,000 millas. Hoy día, los vehículos cuentan con más accesorios que son operados por una sola banda que en el pasado.
